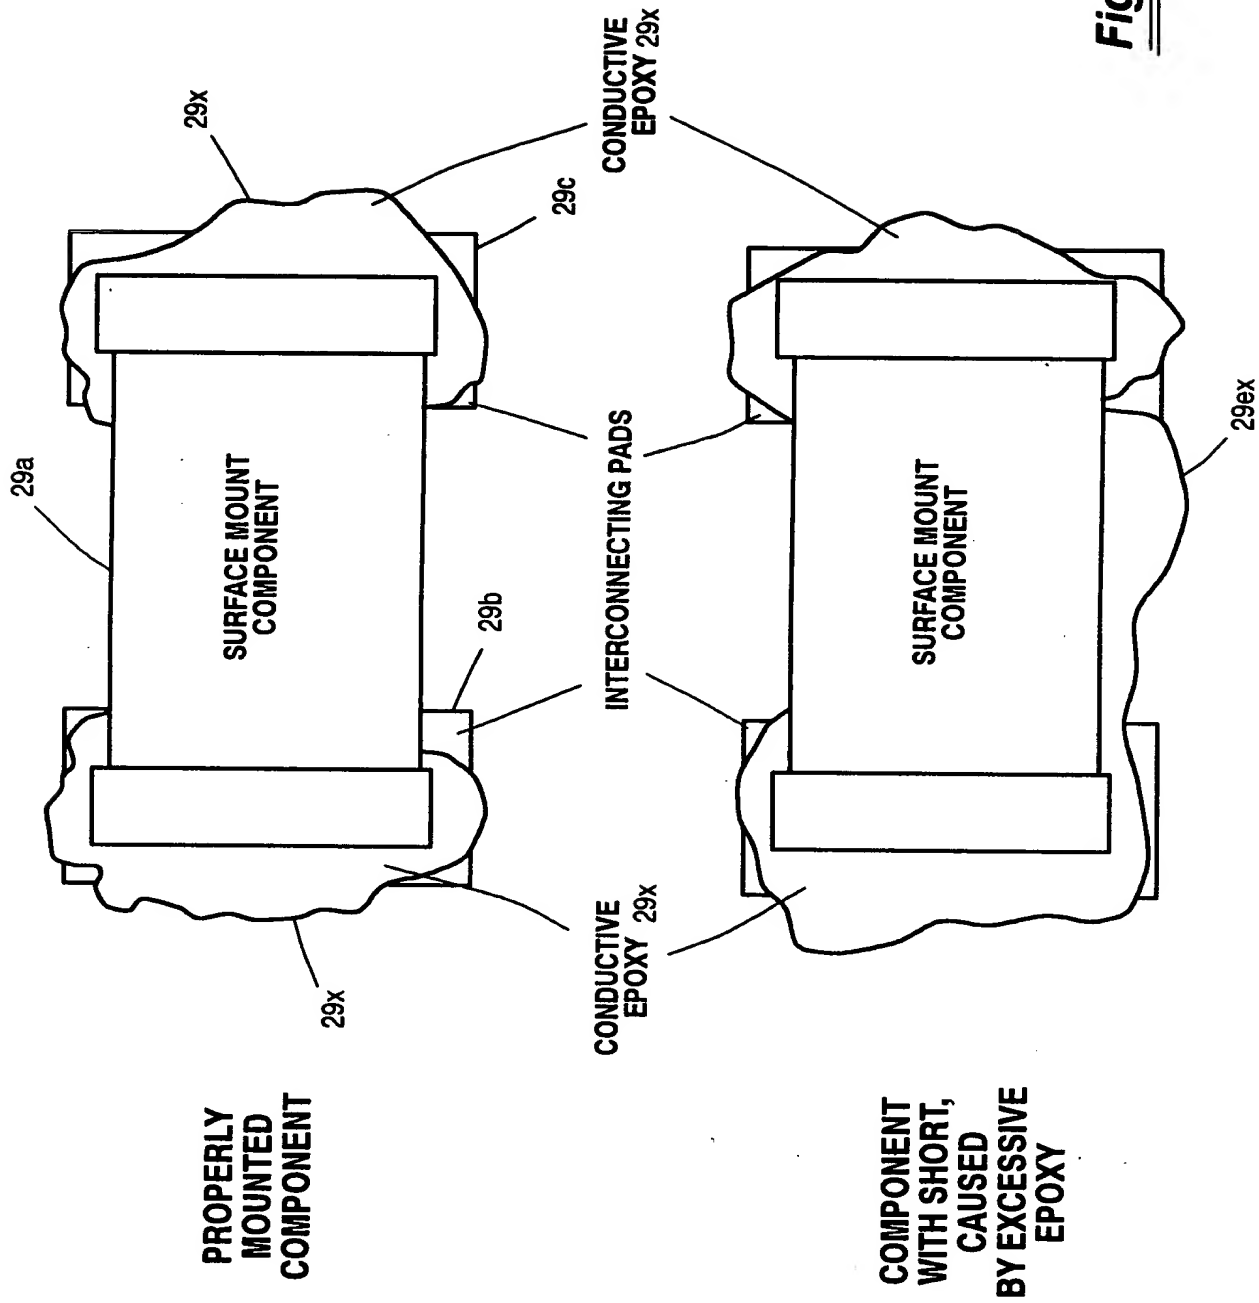
**Figure 2A**

MULTICHIP CERAMIC PACKAGE 28

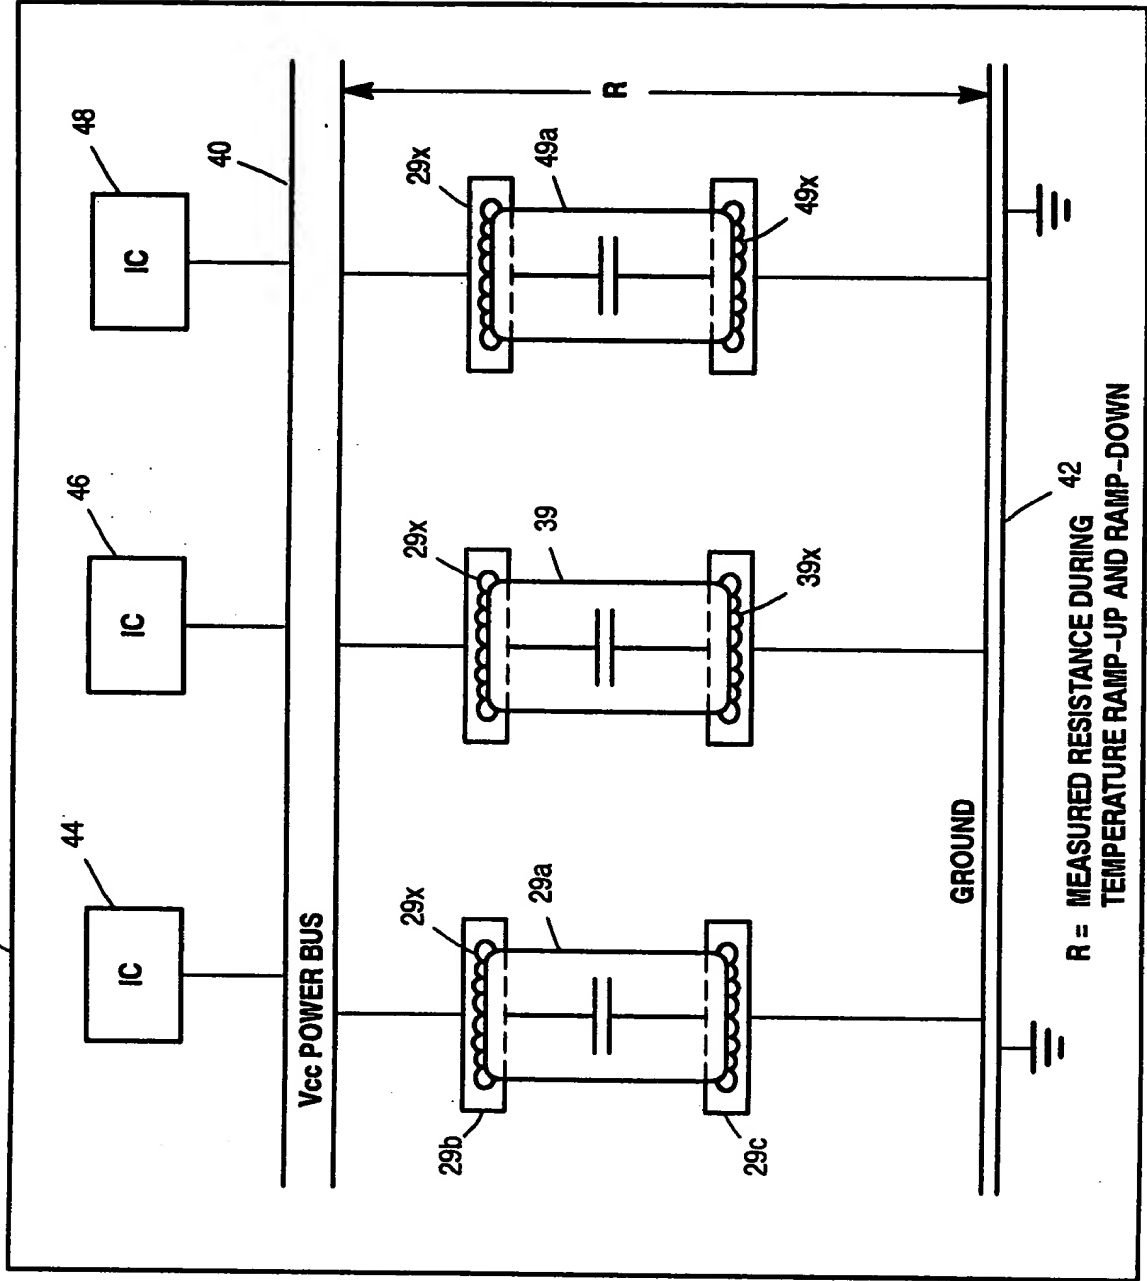
**Figure 2B**

DEFECTIVE PART WITH INTERMITTENT SHORT (W1008)

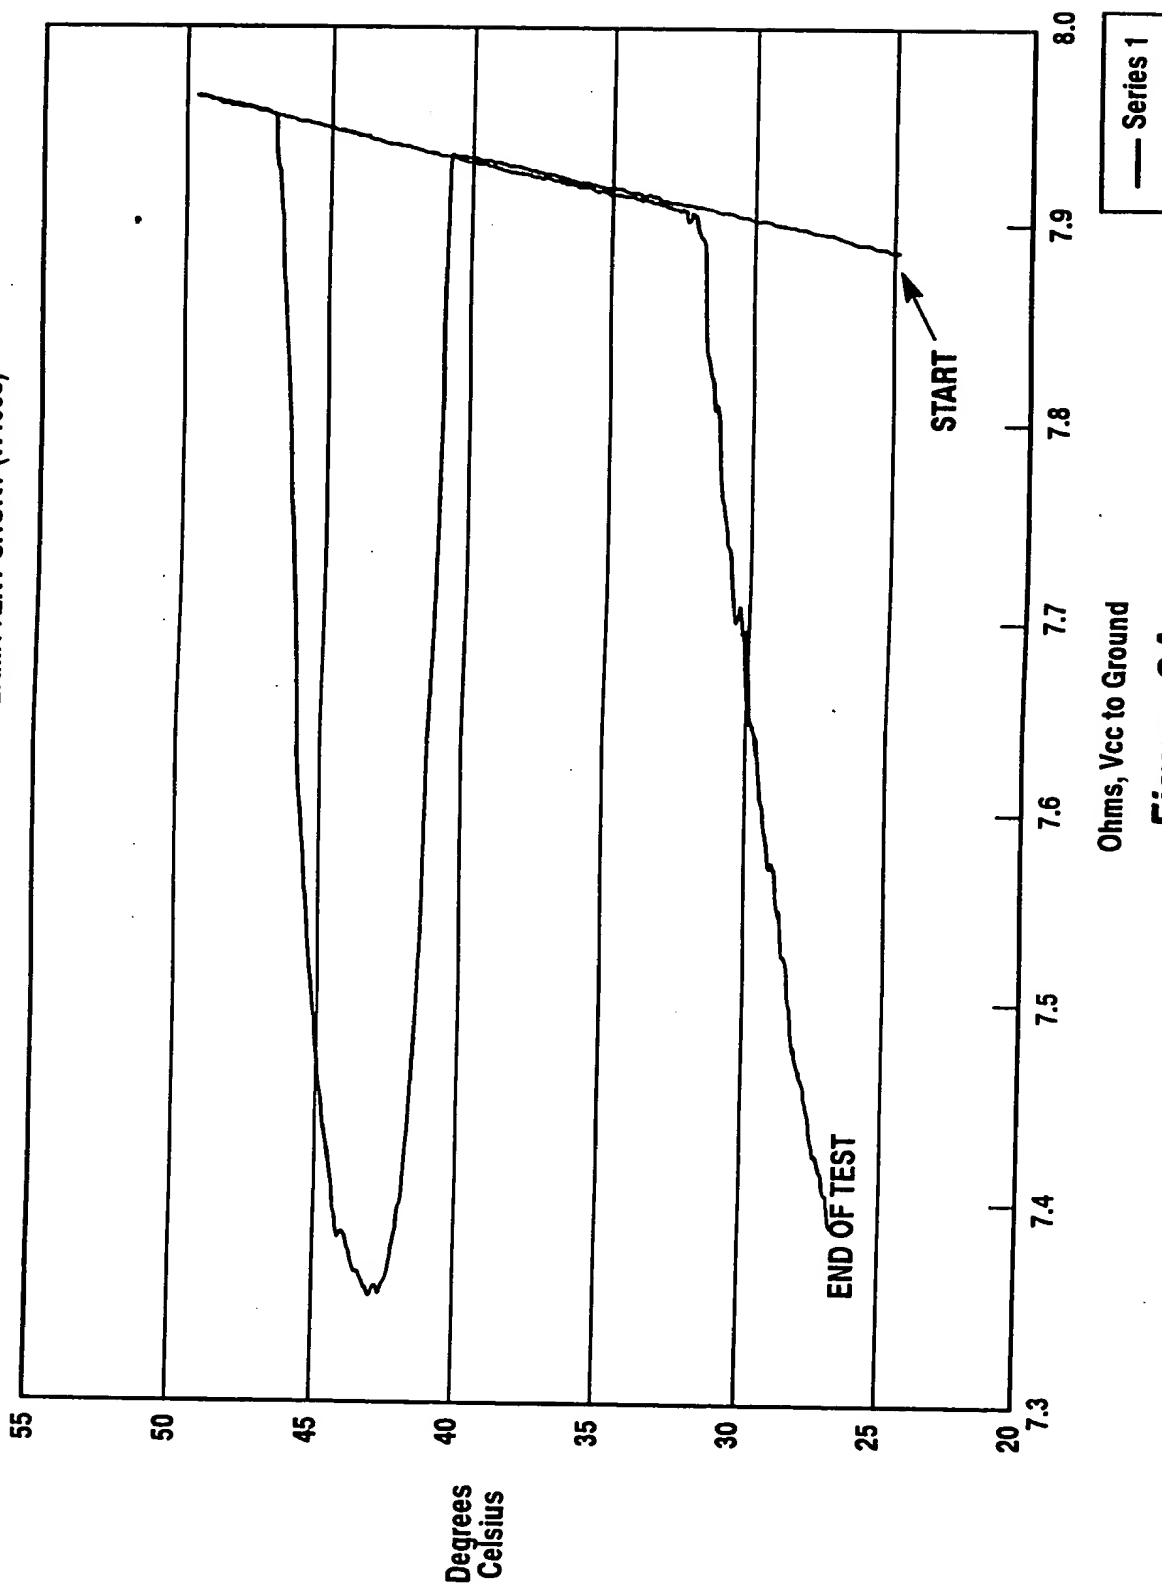
**Figure 3A**

Ohms, Vcc to Ground

PART W1008 AFTER REMOVAL OF SHORT
